CHAPTER THREE: DESCRIPTION OF THE AFFECTED ENVIRONMENT

3.1 INTRODUCTION

Subject to the outcome of the assessment process, specialist studies, technical input and consultation process, the proponent, San Miguel Fruits SA (Pty) Ltd, proposes to expand citrus production at their existing operations on Portion 2 of Farm 92, known as Sylvania, which measures approximately 243.82ha in extent. Sylvania is an existing, working farm and the proponent proposes to transform a portion on the western section of the farm, which measures approximately 115ha. Irrigation of the proposed agricultural development requires the construction of a new dam with a capacity of approximately 30 000m³ (0.5ha footprint) and the installation of irrigation pipelines of varying diameters. A detailed project description is provided in Chapter Two of this report.

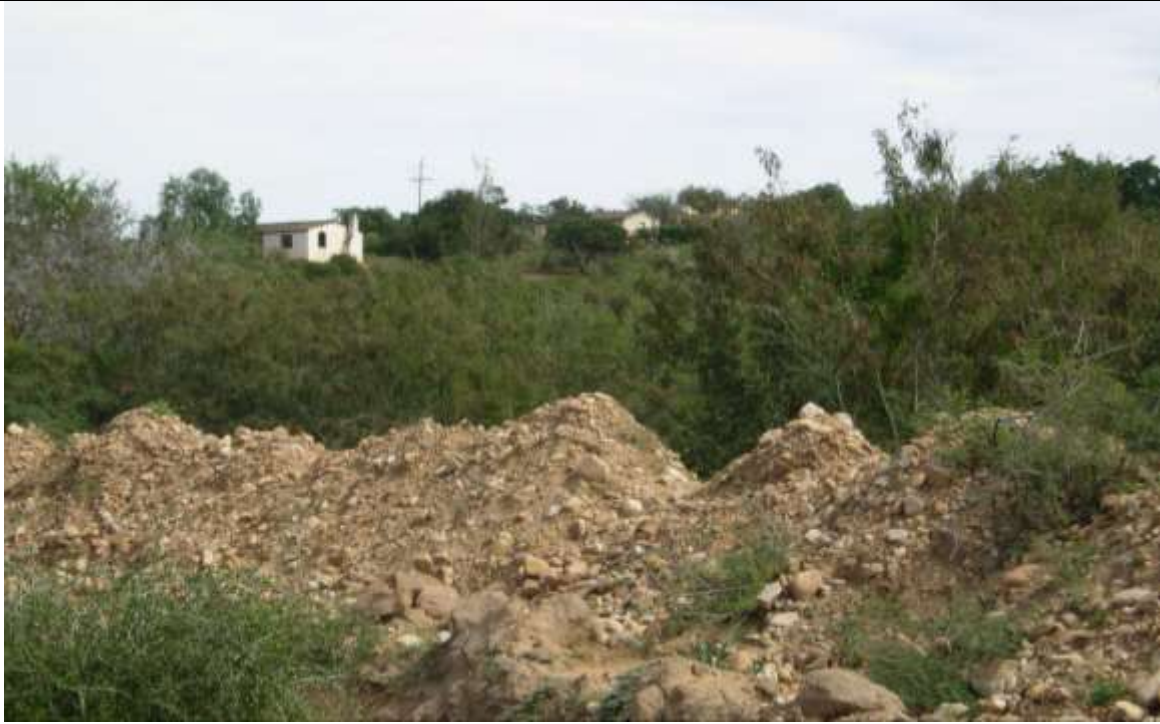
Photo 3.1: Looking towards the western boundary of the area under assessment: the trench that has been dug along the eastern boundary of the area under assessment. Ruined buildings can be seen in the background.

A settlement area comprising of early farmhouses, numerous modern refuse piles, several dilapidated and ruined cinderblock buildings, some with adjacent reed and daub structures, as well as the remains of many old kraal structures, were noted towards the southwestern boundary of the area under assessment. A single, recent residence, currently occupied by the site caretaker, was sighted in the vicinity. This is the only structure that is not ruined. Additionally, a graveyard ranging from formal, enclosed graves, to informal stone-packed burial mounds, was observed in the area (See Photo 3.1, 3.4 and 3.5).

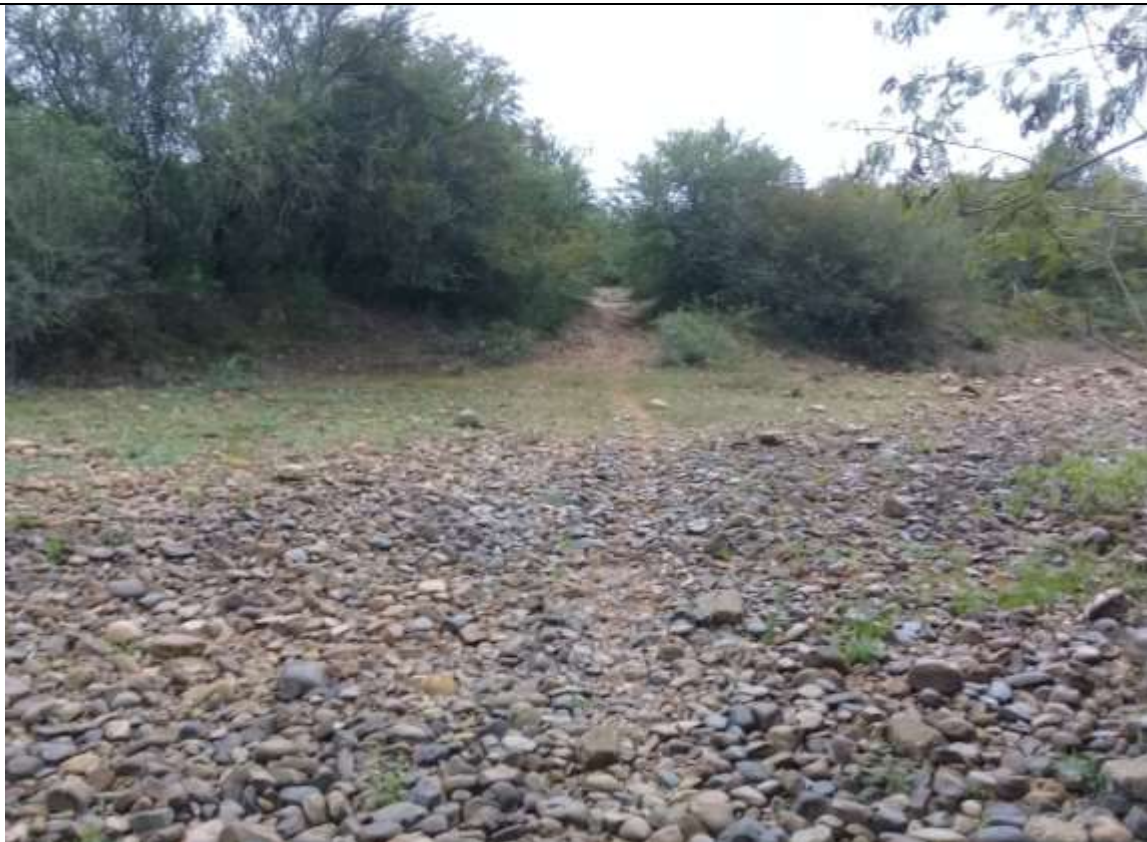
Photo 3.2: Existing low-level crossing of the Wit River proposed to be utilised in order to access the proposed development area.

Although portions of Sylvania are under citrus cultivation, there are no agricultural activities taking place on the area under assessment. However, the eastern boundary of the area under assessment is adjacent to existing citrus orchards. A trench, with a depth of approximately 2m, has been dug along the entire eastern boundary of the area under assessment, in order to keep roaming animals away from the existing citrus orchards on the eastern portion of Sylvania (See Photo 3.1). The Wit River runs along the eastern boundary of the area under assessment. An existing low-level crossing, towards the southern boundary, is proposed to be utilised to access the proposed agricultural development (See Photo 3.2). At the time of the site visit, no water was flowing in the Wit River in the vicinity of the existing low-level crossing.

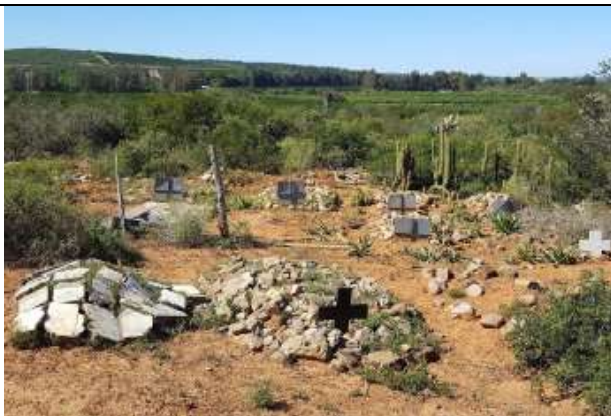
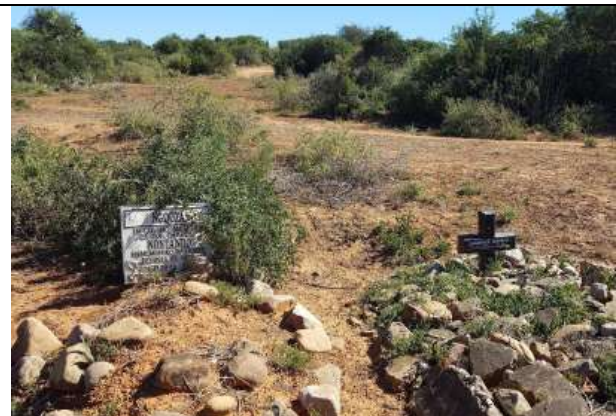
Photo 3.5: Portions of the graveyard associated with the settlement area.

Associated with the settlement area previously mentioned under Section 3.3.1.3, was a graveyard with recent gravestones (approximately 10 years old; See Photo 3.5). Preliminary specialist input has recommended a no-go buffer area around the graveyard. Additionally, the remaining structures associated with the settlement area are deemed to be of low archaeological sensitivity and cultural significance. However, during the EIA phase of the assessment, these areas should be surveyed for the presence of any material which might be of archaeological importance (Phase 1 Archaeological Assessment), or which may have potential impacts on the development.

- The Heritage Screener recommended that a Phase 1 Archaeological Impact Assessment be undertaken.
 - Recommendations with regards to a suitable buffer, no-go area, around the grave yard on the site.
