CHAPTER THREE: DESCRIPTION OF THE AFFECTED ENVIRONMENT

Subject to the outcome of the assessment process, specialist studies, technical input and consultation process, the applicant, San Miguel Fruits SA (Pty) Ltd, proposes to expand citrus production at their existing operations on Portion 2 of Farm 92, known as Sylvania, which measures ~243.82ha in extent. Sylvania is an existing, working farm and the area under assessment is located on the western section of the farm and measures ~115ha. A detailed project description is provided in Chapter Two of this report.

3.2.1 Site Locality and Overview

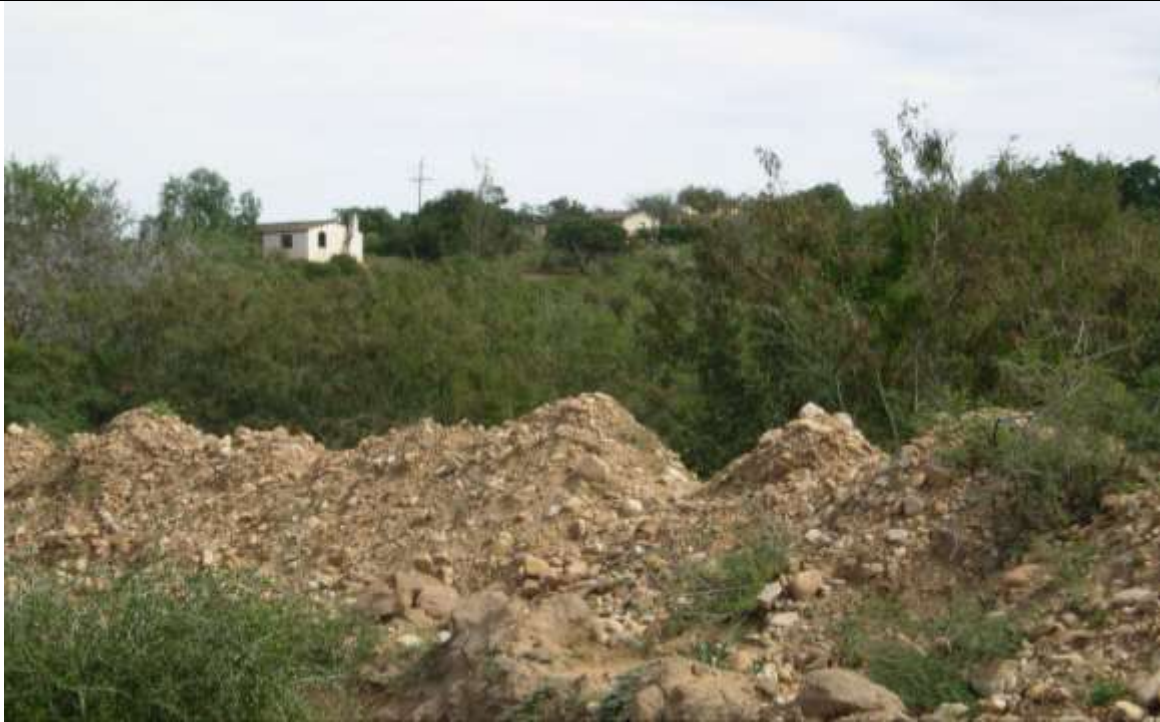
Photo 3.1: Looking towards the western boundary of the area under assessment: the trench that has been dug along the eastern boundary of the area under assessment. Ruined buildings can be seen in the background.

A settlement area comprising of early farmhouses, numerous modern refuse piles, several dilapidated and ruined cinderblock buildings, some with adjacent reed and daub structures, as well as the remains of many old kraal structures, were noted towards the southwestern boundary of the area under assessment. A single, recent residence, currently occupied by the site caretaker, was sighted in the vicinity. This is the only structure that is not ruined. Additionally, a graveyard ranging from formal, enclosed graves, to informal stone-packed burial mounds, was observed in the area (Photo 3.1, 3.4 and 3.5).

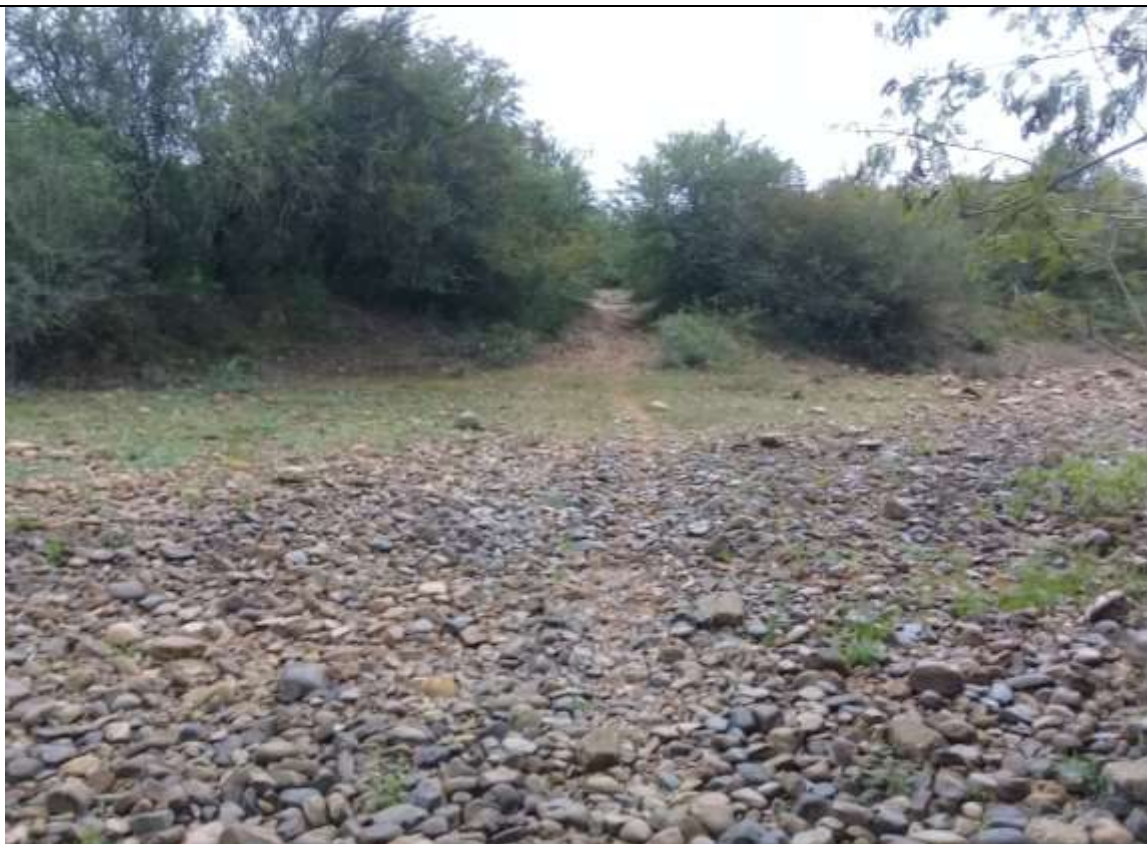
Photo 3.2: Existing low-level crossing of the Wit River proposed to be utilised in order to access the proposed development area.

Although portions of Sylvania are under citrus cultivation, there are no agricultural activities taking place on the area under assessment. However, the eastern boundary of the area under assessment is adjacent to existing citrus orchards. A trench, with a depth of ~2m, has been dug along the entire eastern boundary of the area under assessment, in order to keep roaming animals away from the existing citrus orchards on the eastern portion of Sylvania (Photo 3.1). The Wit River runs along the eastern boundary of the area under assessment. An existing low-level crossing, towards the southern boundary, is proposed to be utilised to access the proposed agricultural development (Photo 3.2). At the time of the site visit, no water was flowing in the Wit River in the vicinity of the existing low-level crossing.

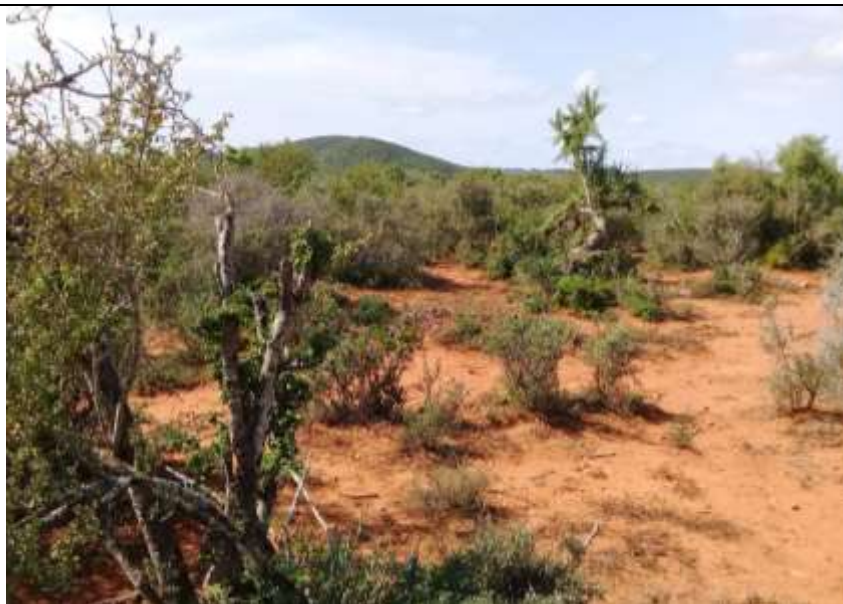
Photo 3.3: Example of reversibly modified areas by livestock browsing, north of the area where the canal has been installed underground.

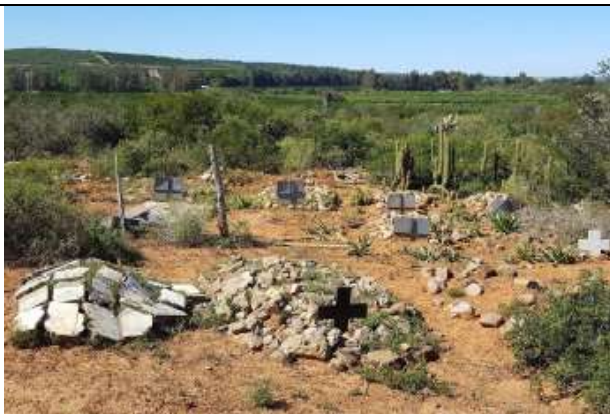
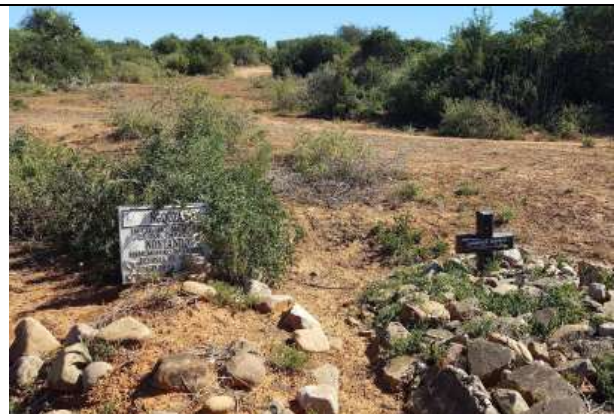
Photo 3.5: Portions of the graveyard associated with the settlement area.

Associated with the settlement area previously mentioned under Section 3.3.1.3, was a graveyard with recent gravestones (~10 years old; Photo 3.5). Preliminary specialist input has recommended a no-go buffer area around the graveyard. Additionally, the remaining structures associated with the settlement area are deemed to be of low archaeological sensitivity and cultural significance. However, during the EIA phase of the assessment, these areas should be surveyed for the presence of any material which might be of archaeological importance (Phase 1 Archaeological Assessment), or which may have potential impacts on the development.

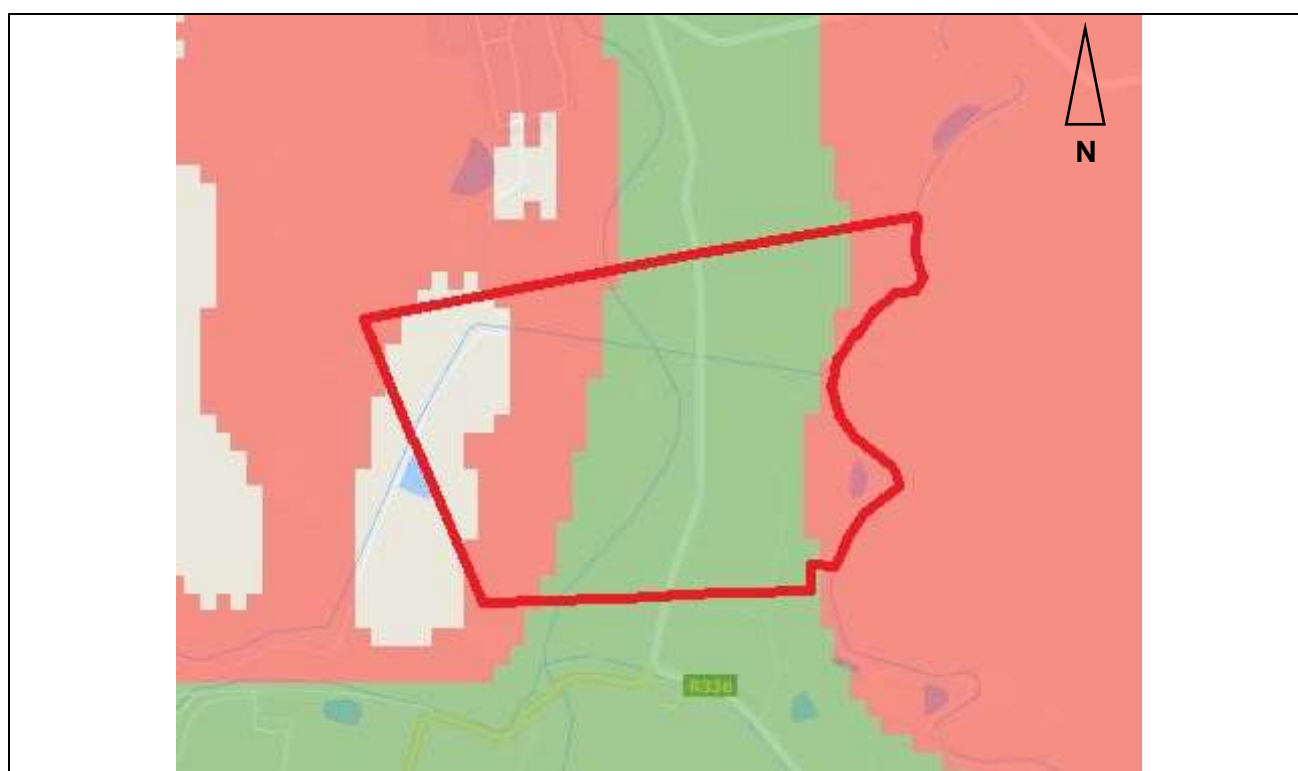
Map 3.10: Fossil Sensitivity of Portion 2 of Farm 92 Tregaron, as given by the SAHRA mapping software.

In terms of the Fossil Sensitivity Map compiled by the South African Heritage Resources Agency (<http://www.sahra.org.za/map/palaeo> Accessed July 2017), the fossil sensitivity on the majority of Sylvania is Moderate (towards the centre) to High (towards the eastern and western boundaries) and largely underlain by the Kirkwood Formation comprising non-marine, fluvial to estuarine mudstone and sandstone sediments of the Early Cretaceous age (Almond 2012, NID 136578)

(Map 3.10). These deposits may contain important examples of Mesozoic land plants (ferns, cycads, conifers etc.) and fossil bones, including large and small dinosaurs, as well as non-marine, and occasional marine, molluscs. There are also isolated patches of Pliocene Kudus Kloof alluvial terrace gravels which, may contain peats, palynomorphs (pollens, spores) and other microfossils, as well as the bones and teeth of mammals and other fauna (Almond 2016, NID 374576).

Despite this potentially high fossil sensitivity, local conditions and previous assessments suggest a low probability of fossil finds. The Kudu’s Kloof Formation in this region would appear not to yield significant fossil material (Almond 2016, NID 374576). Furthermore, the nature of the proposed agricultural development is unlikely to result in deep excavations into bedrock.
