## CHAPTER THREE: DESCRIPTION OF THE AFFECTED ENVIRONMENT

### **3.2.1 Site Locality and Overview**

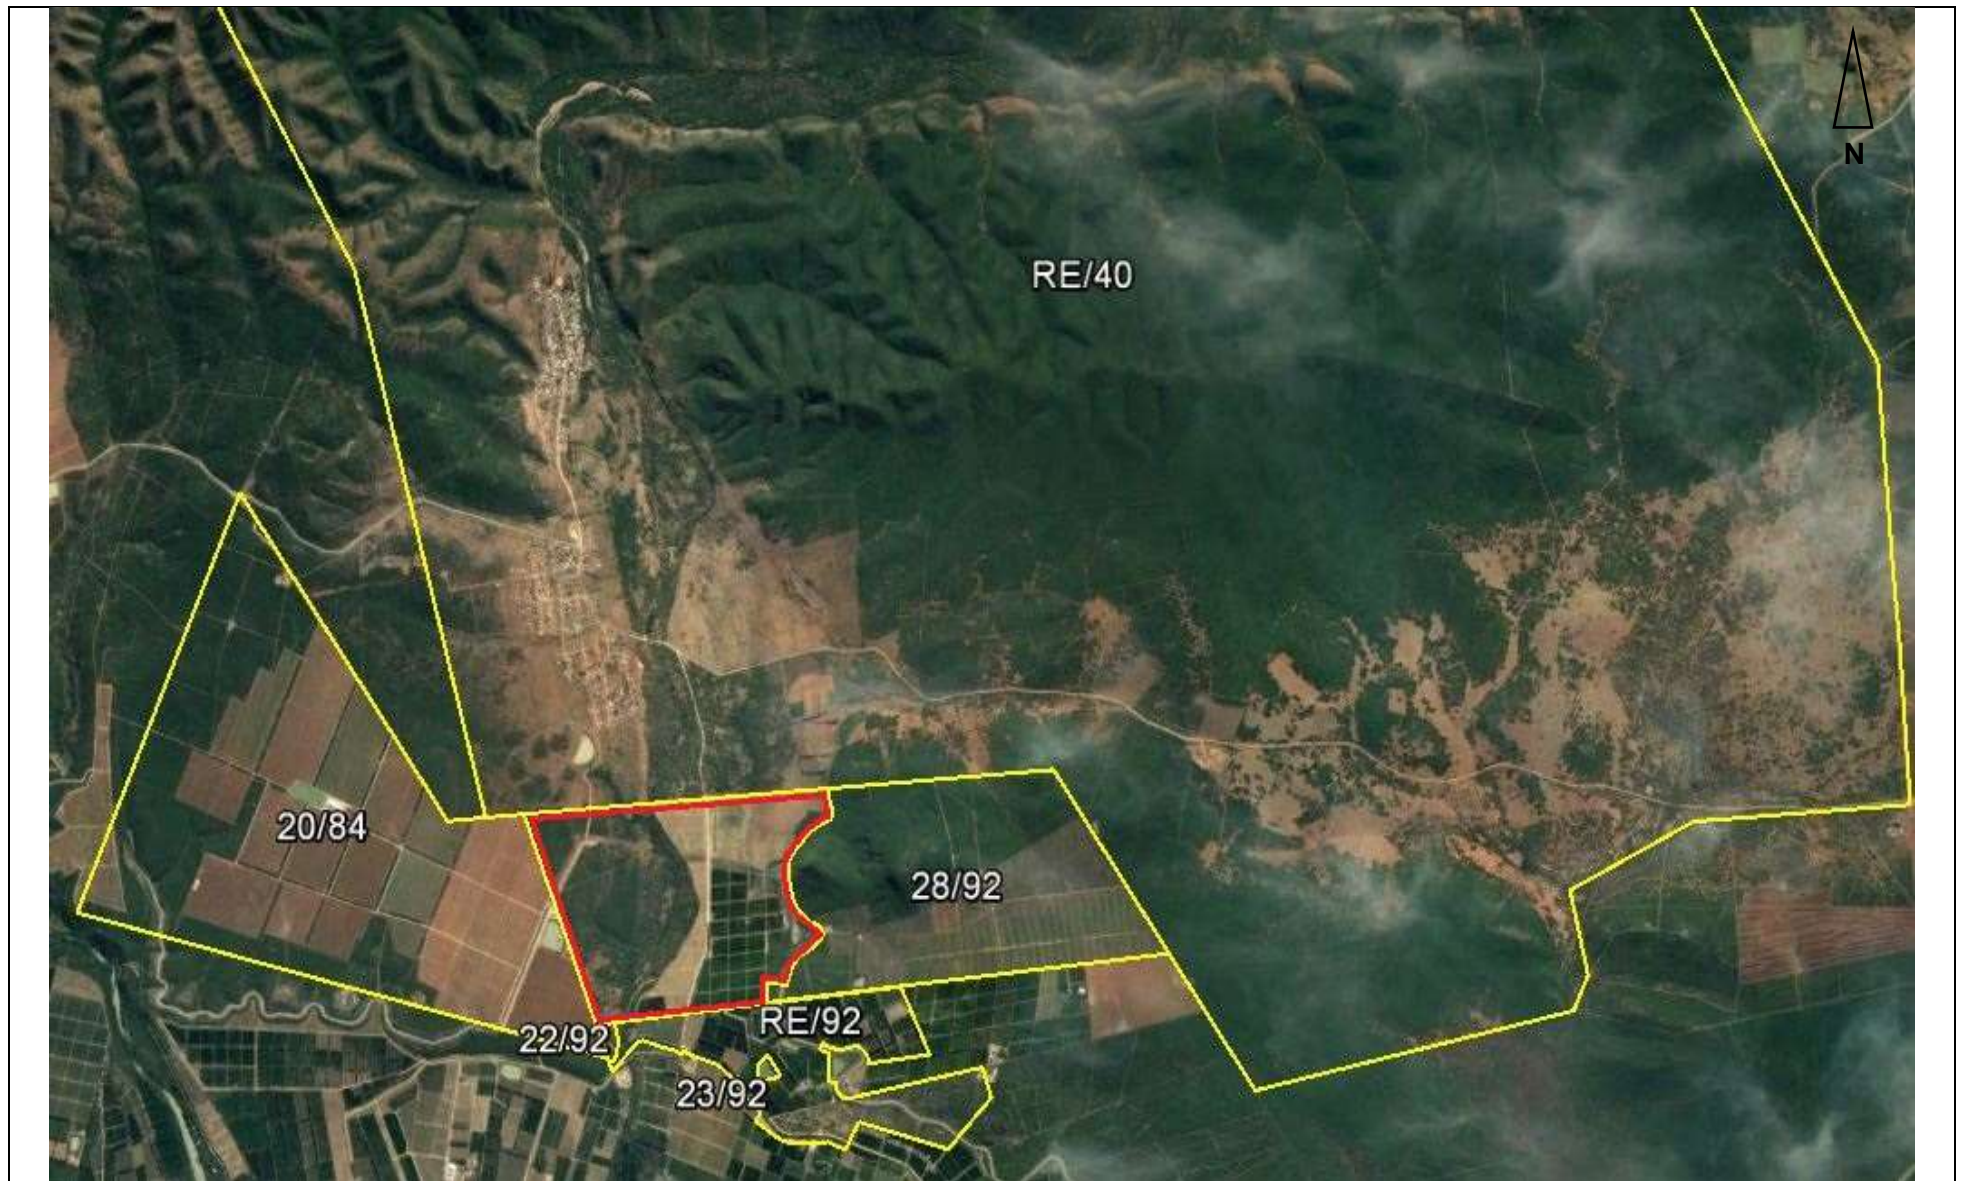
Map 3.2: Properties (yellow outline) adjacent to Portion 2 of Farm 92 Tregaron, Sylvania (red outline).

Sylvania is adjacent to six properties (Map 3.2). These properties, with their associated activities, are listed in Table 3.1 below. Untransformed vegetation is largely restricted towards the northern and north-eastern properties adjoining the farm. The majority of properties surrounding the farm are under cultivation, while the northern boundary of the farm is adjacent to the Bersheba settlement and associated communal farming activities. Based on the surrounding land uses mentioned above, the proposed agricultural development on Sylvania is not likely to cause a significant change in character within the surrounding landscape, as the surrounding area is currently predominantly agricultural in nature. As a result, the focus of this EIA has been on the potential of the site for the planting of citrus orchards, as well as areas for conservation, guided by technical and biophysical constraints which have been determined through relevant specialist studies. Additionally, the assessment has considered the proximity of the proposed agricultural development to the Addo Elephant National Park (Map 3.1) and potential impacts thereon, due to the triggering of related listed activities in the NEMA EIA Regulations, 2014 (as amended). See Chapter Four for the full list of activities triggered and Chapters Six to Ten for the various specialist studies conducted.

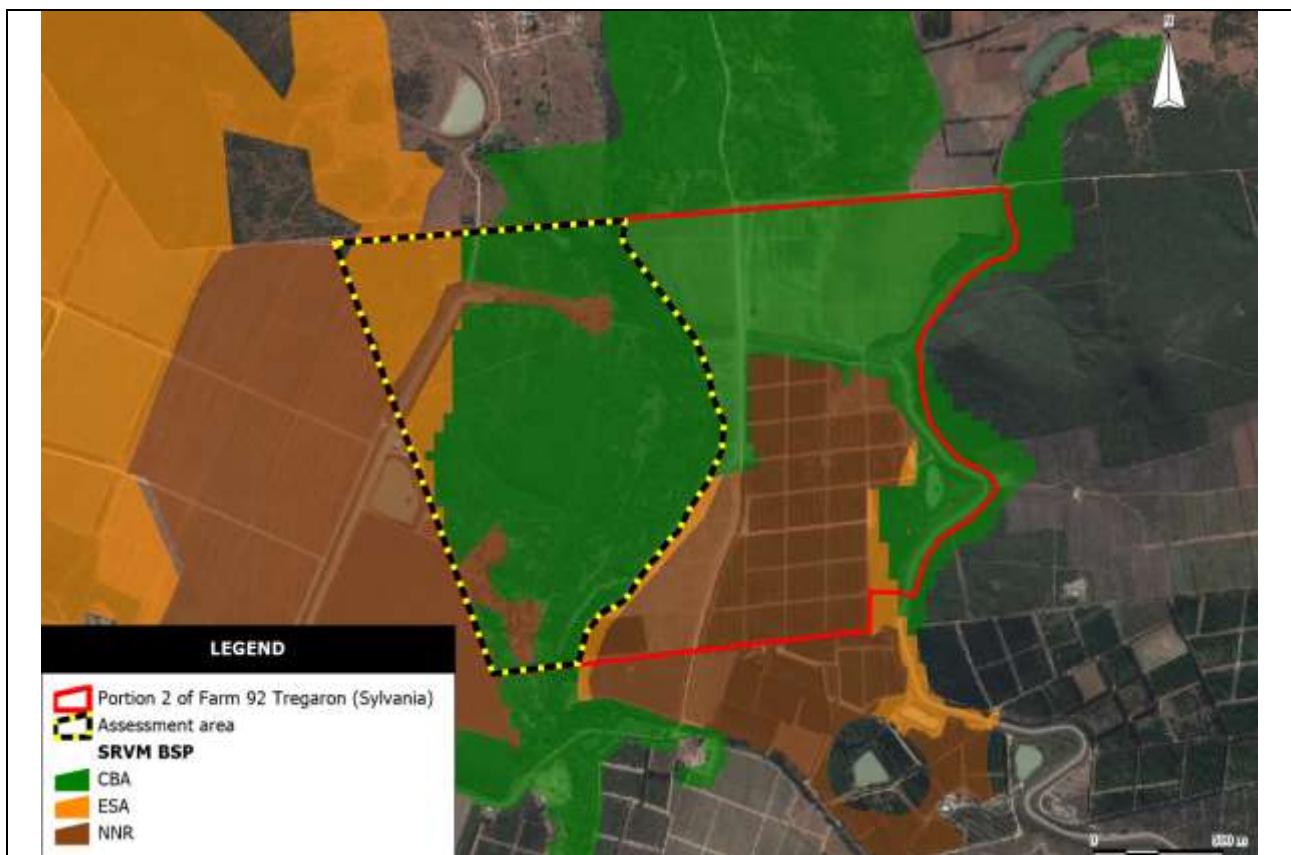
Map 3.9: The area under assessment (yellow and black outline), which is situated on Portion 2 of Farm 92 Tregaron, known as Sylvania, as mapped in the SRVM Biodiversity Sector Plan mapping resources.

In terms of the SRVM BSP, the majority of the area under assessment is mapped as Critical Biodiversity Area (CBA). Three portions along the north-western, southern and eastern boundaries have been mapped as Ecological Support Area (ESA). The remainder of the area under assessment has been mapped as No Near Natural Area Remaining (NNR) (Map 3.9). The area mapped as CBA reflects the river reach and catchment area of the Wit River, which traverses the site. The ESA is an extension of the mapped CBA area, which represents a functional zone that maintains the natural processes associated with the catchment.

The importance of the vegetation on the area under assessment in maintaining CBAs and ESAs has been assessed by a vegetation, as well as an aquatic specialist during the EIA phase of this assessment (See Chapters Six and Seven).

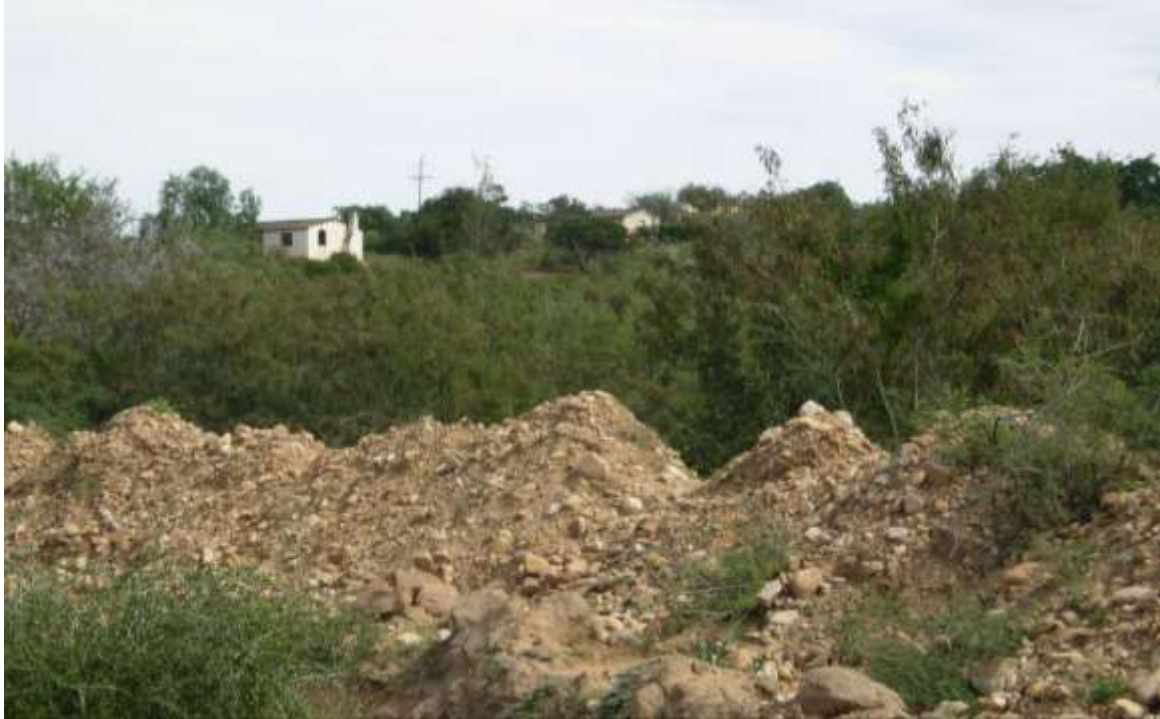
*Photo 3.1: Looking towards the western boundary of the area under assessment: the trench that has been dug along the eastern boundary of the area under assessment. Ruined buildings can be seen in the background.*

A settlement area comprising of early farmhouses, numerous modern refuse piles, several dilapidated and ruined cinderblock buildings, some with adjacent reed and daub structures, as well as the remains of many old kraal structures, were noted towards the southwestern boundary of the area under assessment. A single, recent residence, currently occupied by the site caretaker, was sighted in the vicinity. This is the only structure that is not ruined. Additionally, a graveyard ranging from formal, enclosed graves, to informal stone-packed burial mounds, was observed in the area (Photo 3.1, 3.4 and 3.5).

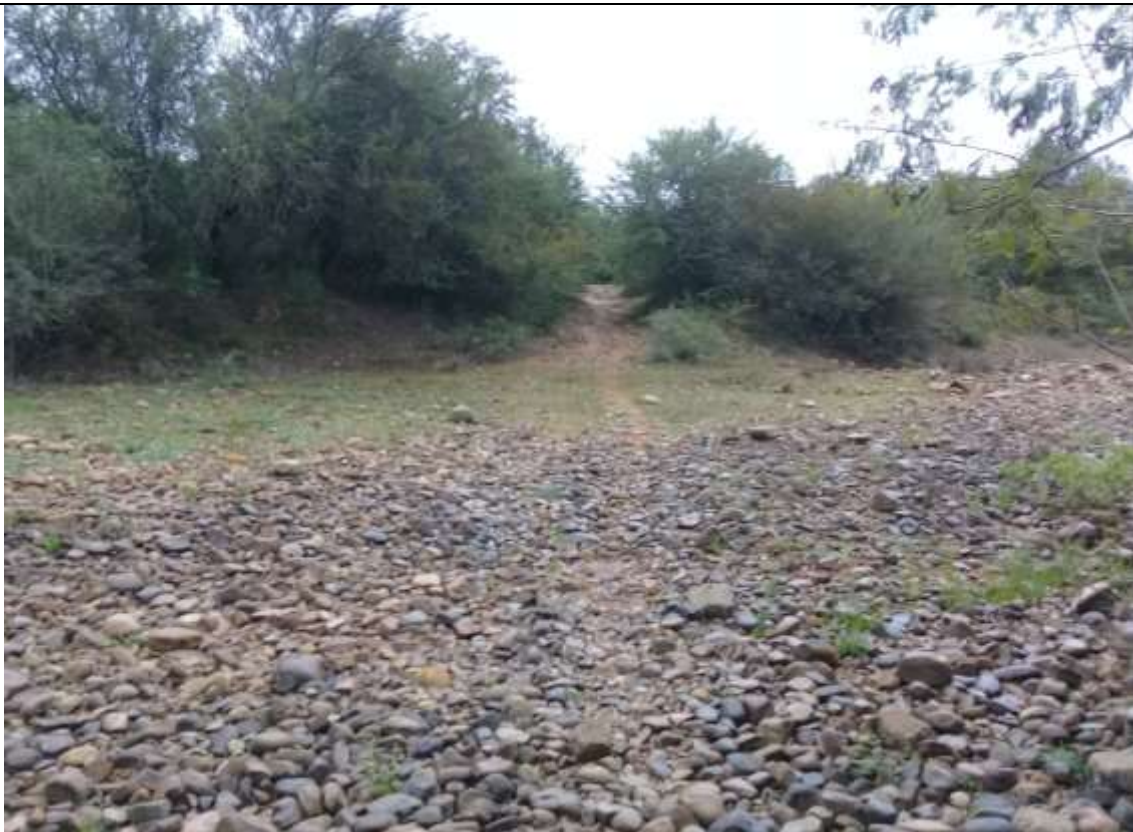
*Photo 3.2: Existing low-level crossing of the Wit River proposed to be utilised in order to access the proposed development area.*

Although portions of Sylvania are under citrus cultivation, there are no agricultural activities taking place on the area under assessment. However, the eastern boundary of the area under assessment is adjacent to existing citrus orchards. A trench, with a depth of ~2m, has been dug along the entire eastern boundary of the area under assessment, in order to keep roaming animals away from the existing citrus orchards on the eastern portion of Sylvania (Photo 3.1). The Wit River runs along the eastern boundary of the area under assessment. An existing low-level crossing, towards the southern boundary, is proposed to be utilised to access the proposed agricultural development (Photo 3.2). At the time of the site visit, no water was flowing in the Wit River in the vicinity of the existing low-level crossing.

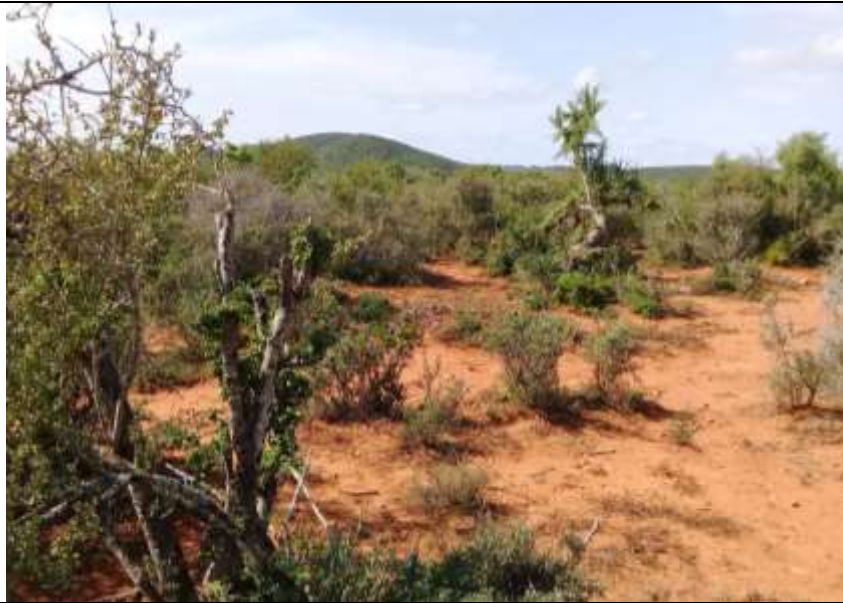
*Photo 3.3: Example of reversibly modified areas by livestock browsing, north of the area where the canal has been installed underground.*

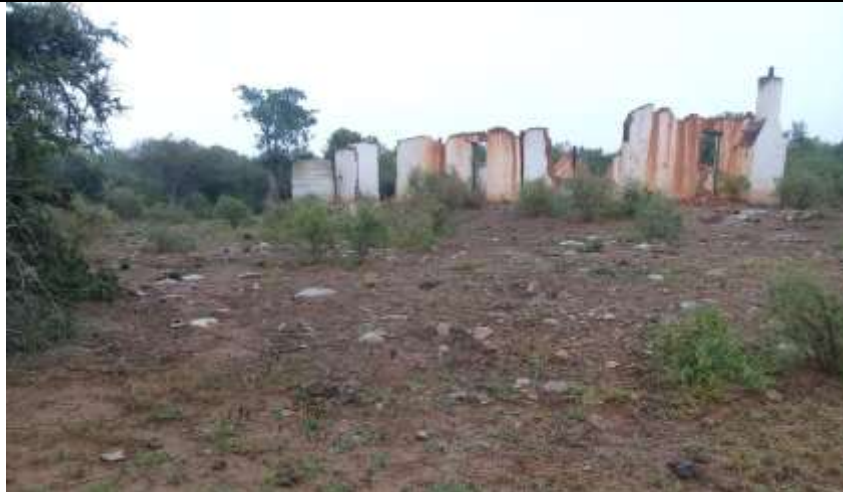
*Photo 3.4: Example of irreversibly modified areas and ruined buildings associated with the historical settlement area.*

The southwestern portion of the area under assessment has been irreversibly modified due to a previous settlement area comprised of early farmhouses and old kraals. The area was most likely historically utilised for subsistence agriculture. Browsing by goats was evident around the settlement area. Additionally, the area surrounding the irrigation canal, including associated vehicle access tracks and paths have resulted in irreversibly modified areas, including where the canal has been installed underground. Livestock grazing was apparent surrounding the irrigation canal, as well as on the floodplain areas, resulting in reversibly modified areas (Photo 3.3). Those areas furthest away from the irreversibly modified areas and on the slopes, were in a better condition, with low degradation levels.

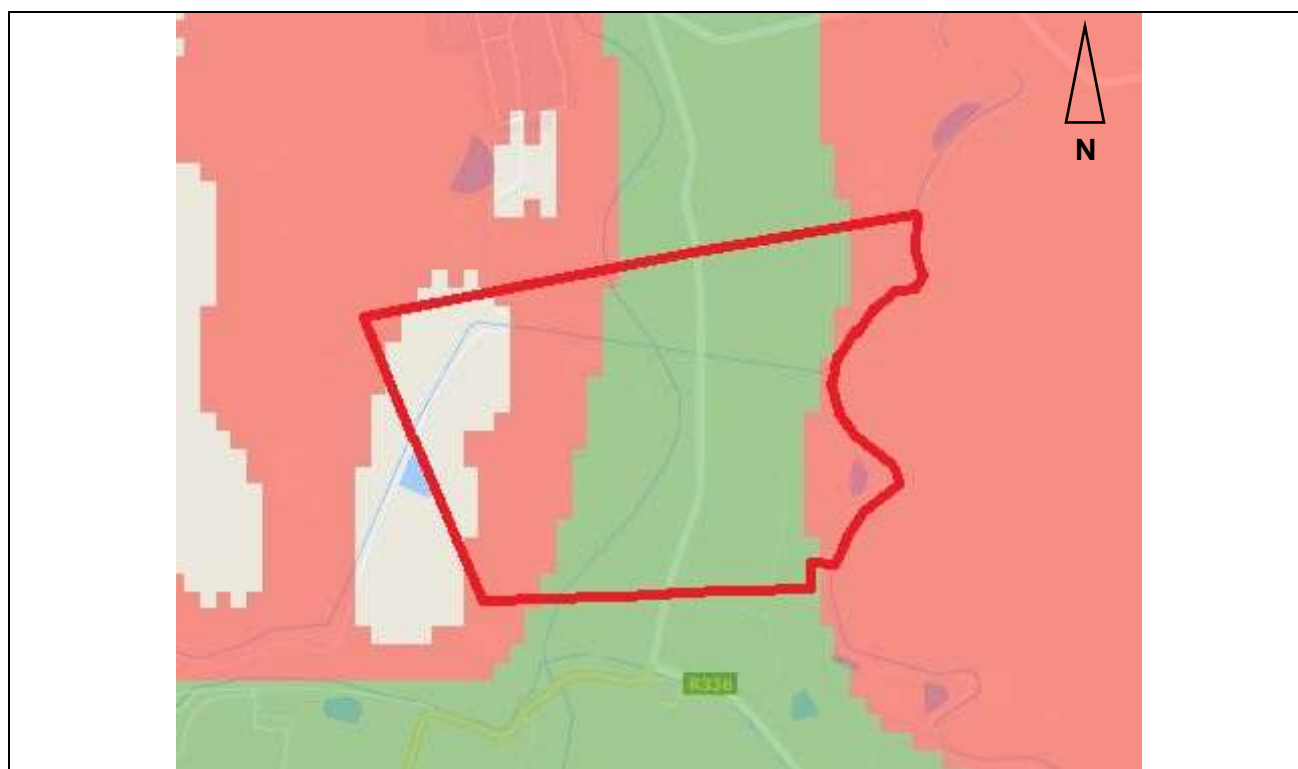
Map 3.10: Fossil Sensitivity of Portion 2 of Farm 92 Tregaron, as given by the SAHRA mapping software.

In terms of the Fossil Sensitivity Map compiled by the South African Heritage Resources Agency (<http://www.sahra.org.za/map/palaeo> Accessed July 2017), the fossil sensitivity on the majority of Sylvania is Moderate (towards the centre) to High (towards the eastern and western boundaries) and largely underlain by the Kirkwood Formation comprising non-marine, fluvial to estuarine mudstone and sandstone sediments of the Early Cretaceous age (Almond 2012, NID 136578)

(Map 3.10). These deposits may contain important examples of Mesozoic land plants (ferns, cycads, conifers etc.) and fossil bones, including large and small dinosaurs, as well as non-marine, and occasional marine, molluscs. There are also isolated patches of Pliocene Kudus Kloof alluvial terrace gravels which, may contain peats, palynomorphs (pollens, spores) and other microfossils, as well as the bones and teeth of mammals and other fauna (Almond 2016, NID 374576).

Despite this potentially high fossil sensitivity, local conditions and previous assessments suggest a low probability of fossil finds. The Kudu’s Kloof Formation in this region would appear not to yield significant fossil material (Almond 2016, NID 374576). Furthermore, the nature of the proposed agricultural development is unlikely to result in deep excavations into bedrock.
